BBPS Tramroad Project End of Year Report

V 1.3 April 2026

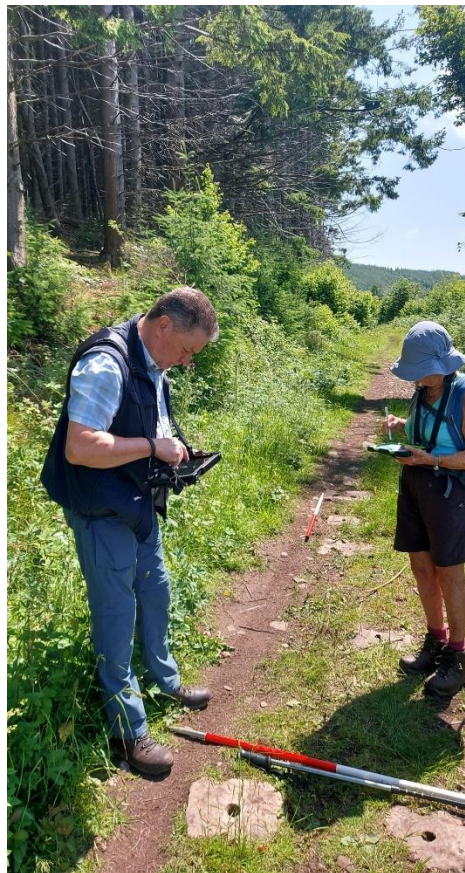
Image 1: Volunteers recording passing bay on Brinore Tramroad

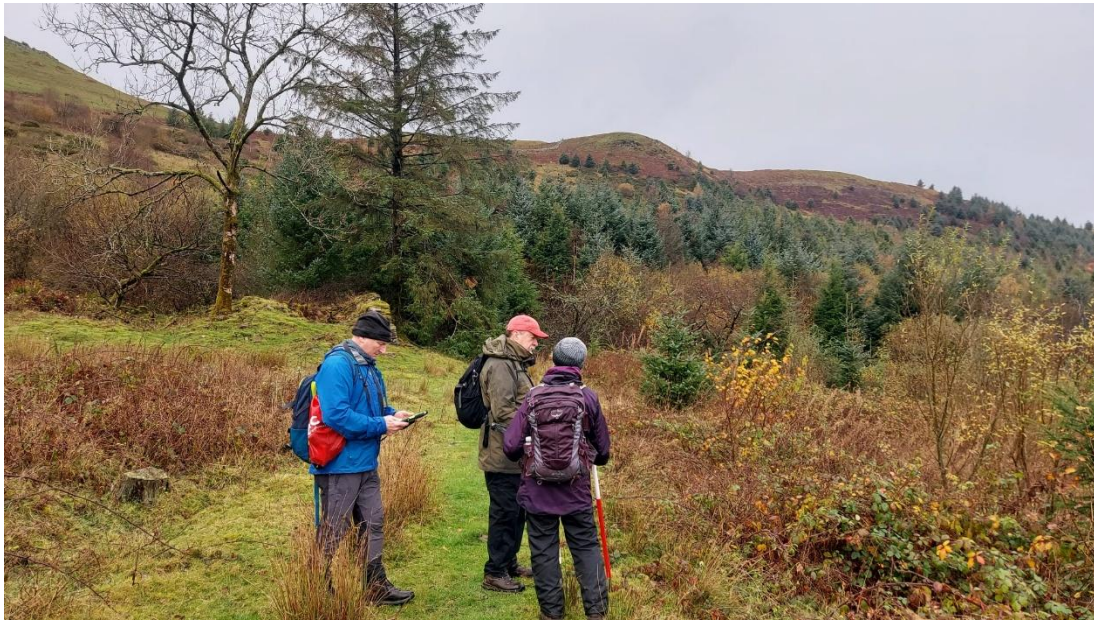
Image 2: Volunteers recording section of Brinore Tramroad

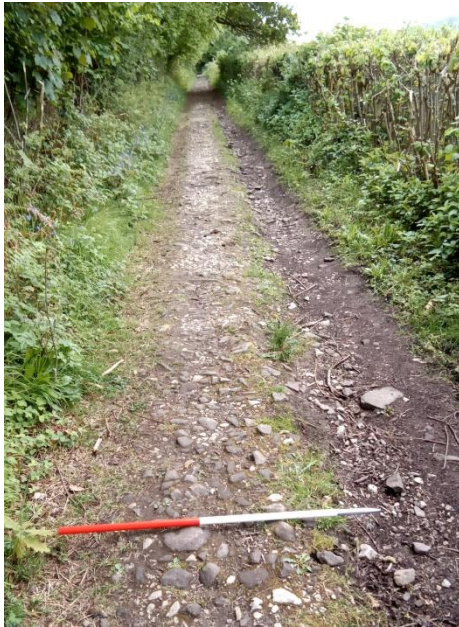
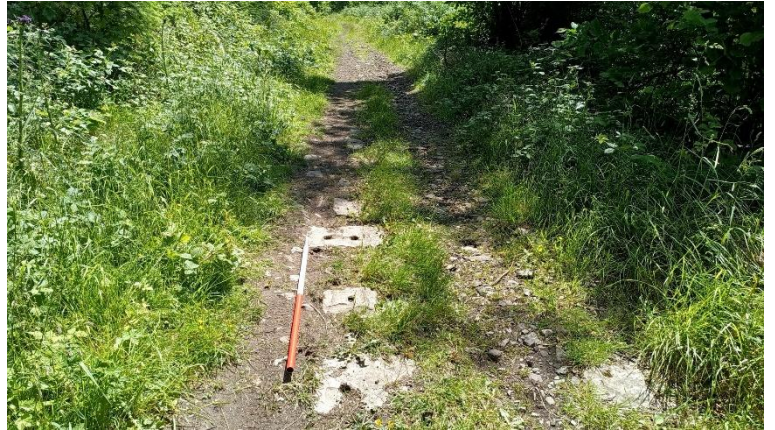
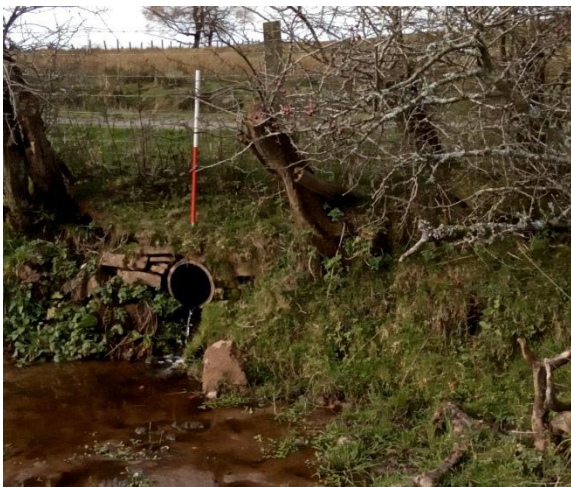
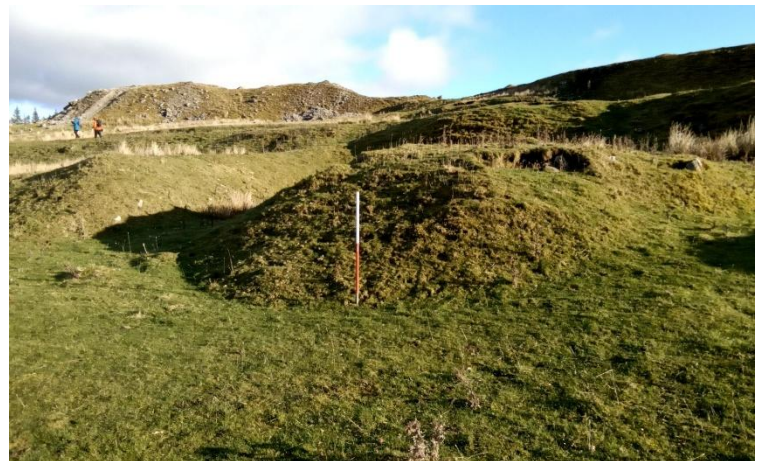
In summary, 14 culverts were in a worsened condition and not functioning as well as they could or completely blocked consequently leading to erosion of the surface of the tramroad in places. Four sections of tramroad were identified as suffering worsened conditions since the last survey, mainly as a result of waterlogging and water erosion. On the whole, however, it is clear that improvements to the drainage elsewhere along the route have made a positive impact to the condition of the tramroad, with the majority of the culverts actively functioning. The majority of tramroad sections and features had not changed since the time of the last survey.

Image 3: Features recorded along Brinore Tramroad - trackbed, stone blocks, culvert and spoil heaps

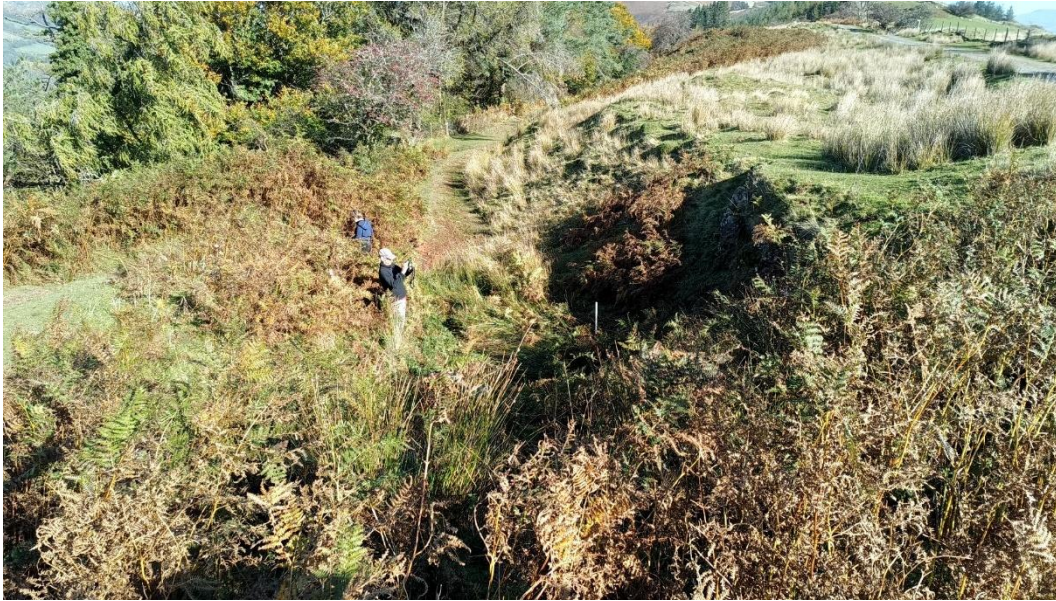
The opportunity to carry out a tangential piece of work on the former Penrhiw Calch Tramroad Bridge and cutting is being explored. The bridge and cutting itself have not been subjects of detailed archaeological recording. During field survey, surviving remains of what could be the original bridge abutments were noted. A photograph of the bridge and cutting from the 1940s appears in Rattenbury (page 119) and the features also form the subject of an iconic Michael Blackmore reconstruction illustration. The BBNP Head of Planning Has been supporting this potential side project by liaising with the tramroad section's landowners, NRW and park authority staff to determine the feasibility of clearing vegetation and soil accumulation to allow detailed archaeological recording of the features to take place.

Image 4: Volunteers recording the cutting at Penrhiw Calch
